First Coast Guard District

SAFETY ALERT

TWO TRAGIC DEATHS; FISHERMEN CAUGHT IN ROTATING SHAFTS

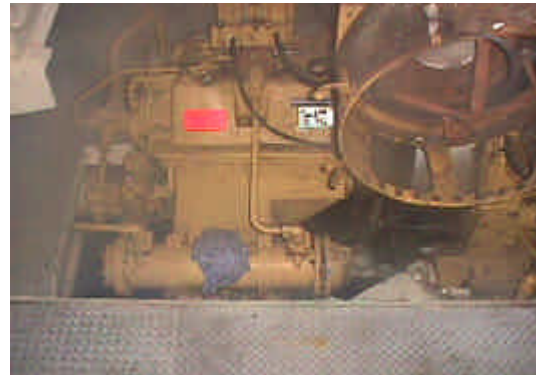
While the exact causes of these accidents are unknown at this time, there is enough information available to alert other fishermen to take special care. In the first incident, the master of the vessel went down below to clear the bilge suction screen. To accomplish this task, the master had to remove a guard and deck plate to get access to the screen. The screen was located below the shaft coupling to the main engine. The master had his lone crewmember stay in the pilothouse with the engine engaged. After a few minutes, when the master did not return, the crewmember went below to check on the situation. His grim discovery was one that he will never forget. It appears that when the master reached around the rotating shaft his clothing became caught on a bolt of the shaft coupling. He was pulled into the shaft that was rotating at 200 times per minute. The accident happened with such speed that no one could have done anything to stop the accident from happening.

are hauntingly similar. In the second instance, the master was working in the engine room with his son present. Apparently, he too was in the vicinity of the rotating shaft and had his clothing get caught. The casualty happened with such rapidity that virtually nothing could be done to save the fisherman. To ponder what the poor son had to witness is more powerful than all the words that have ever been spoken about safety on fishing vessels.

- Disengage the machinery before working near it
- Do not wear loose clothing in the vicinity of moving machinery
- Guards should be installed in way of machinery that can cause injury to crewmembers, such as gearing, chain or belt drives, and rotating shafting. For documented fishing vessels operating beyond the boundary line this is a federal requirement.
- Machinery spaces should be maintained in a manner that provides safe and free access to all machinery and equipment that may require servicing at sea.
